Property Inspection Report

**10013 East Harmon Avenue
Las Vegas, NV 89119**

April 12th, 2019

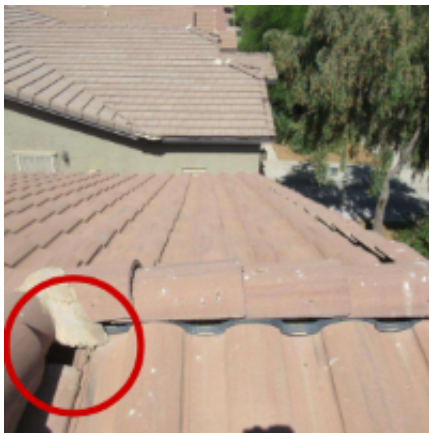
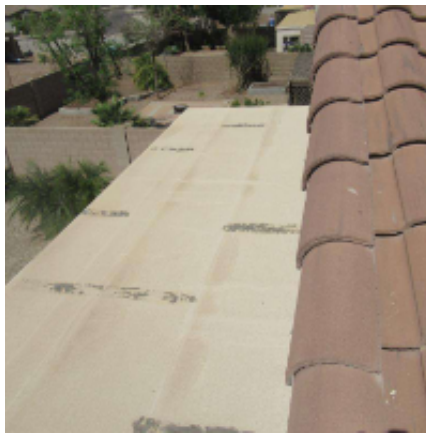
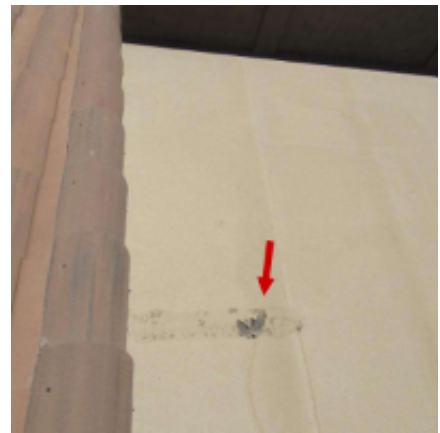
Tile slipped from original position at north center gable above garage. Repairs may be made by the homeowner or a handyman. Peeling coating from roofing joints on the south patio roof.

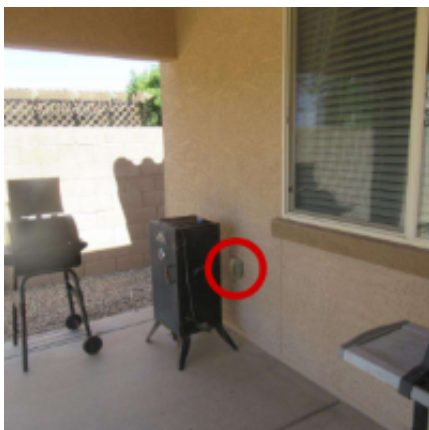
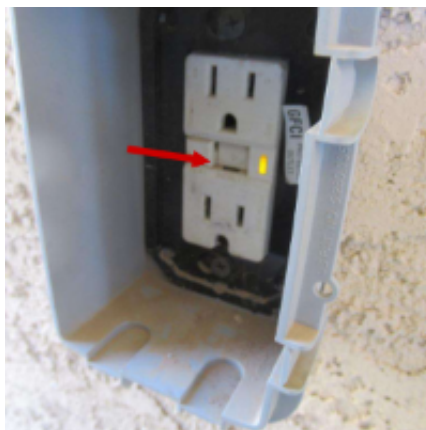
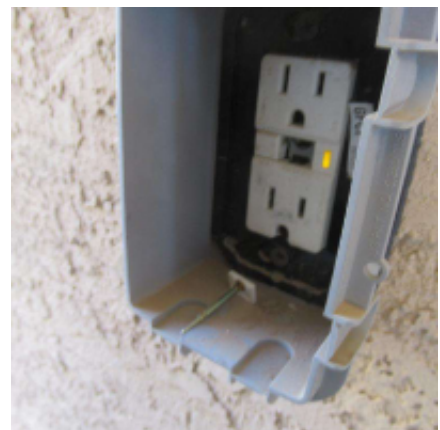
The test button on the GFCI is broken and should be repaired or replaced immediately.

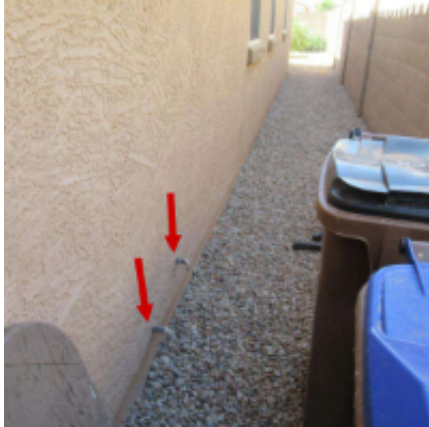
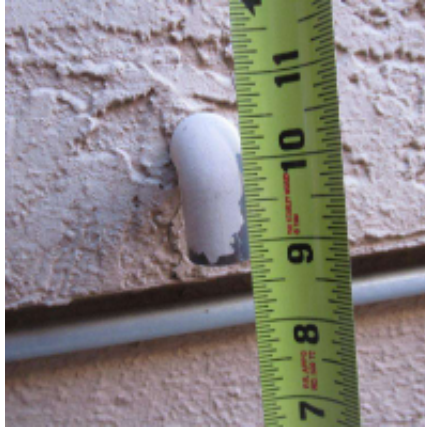
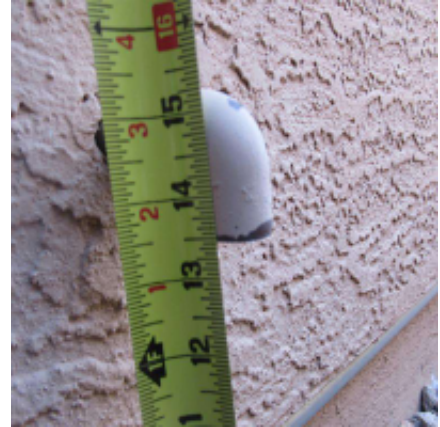
Water heater discharge pipe is too short/far from ground. Steam dissipation can cause scalding to those standing nearby. Typically this should terminate 6 inches from the ground, but may vary by jurisdiction.

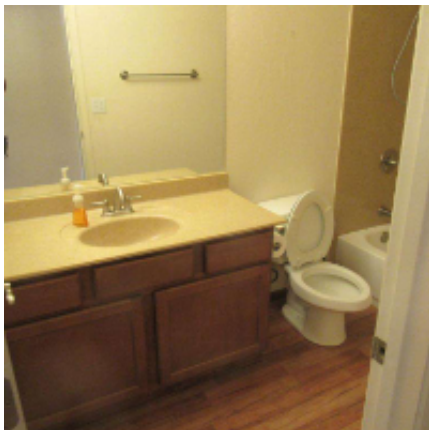
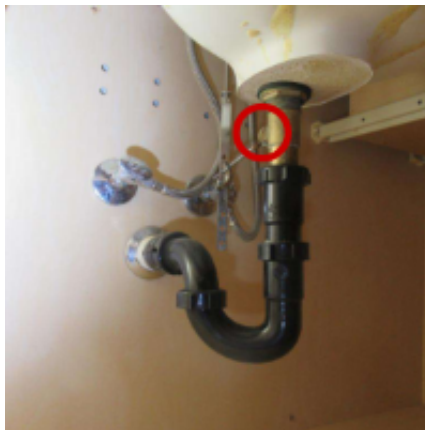
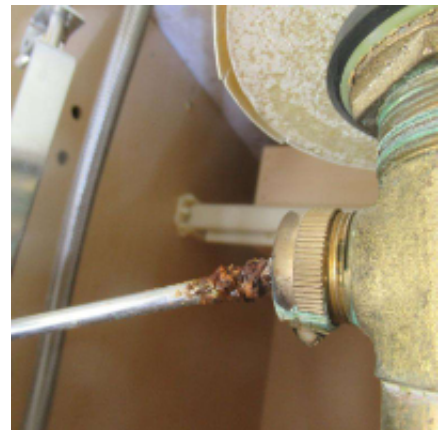
A leak is present at the stopper rod/drain connection. The mechanism can be dismantled to check seals for wear or cracks.

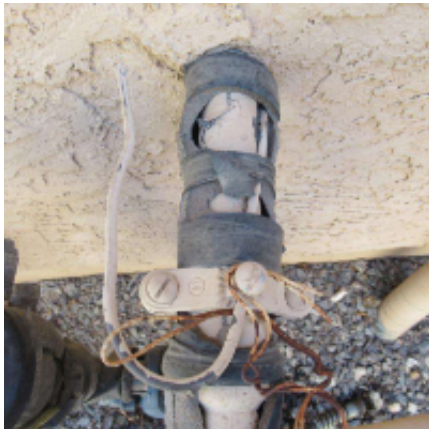
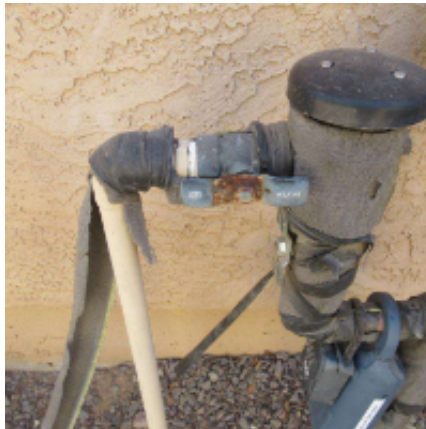
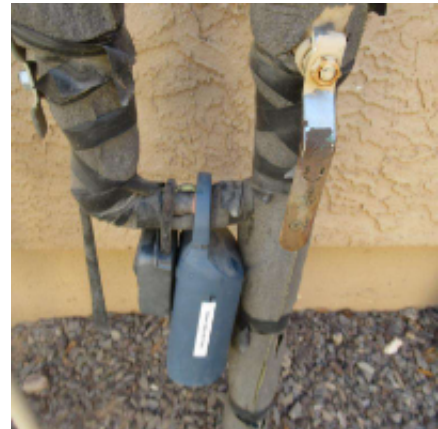
Image 1.1.1

1.1 Hose Bibbs / Outdoor Faucets Exterior	Description	• Anti-siphon	Location	• Exterior • West Side
	Condition	• Deteriorated Insulation	Risk	• Freezing during extreme weather in winter

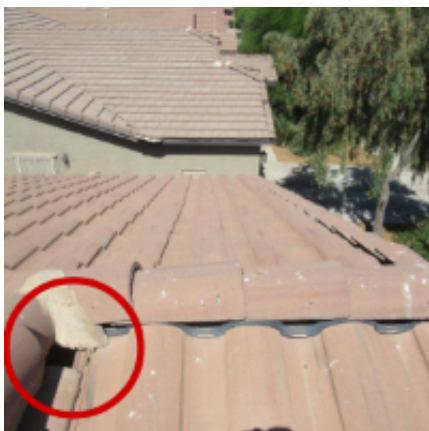
Repair or Replace - Immediately: Tile slipped from original position at north center gable above garage. Repairs may be made by the homeowner or a handyman.

Image 2.2.1 Roof tile has slid out of place - NE Corner of Home

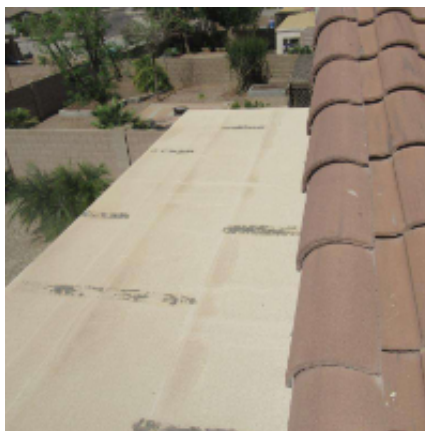
Peeling coating from roofing joints on the south patio roof.

Image 2.2.2 Peeling coating from joints on patio roof

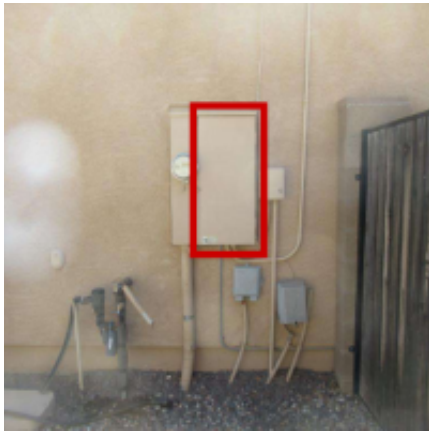
Image 3.2.1

Please take note of the location of the panel, as it will need to be accessed to reset breakers during home ownership.

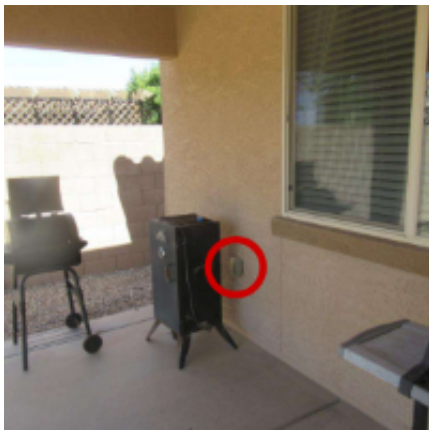
Repair or Replace - Immediately: The test button on the GFCI is broken and should be repaired or replaced immediately.

Image 3.3.1 Broken GFCI Location

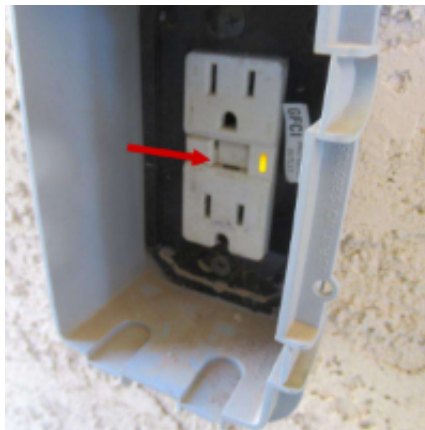
Image 3.3.2 Broken GFCI Test Button

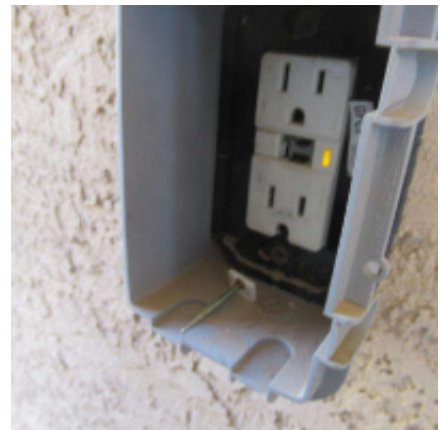
Image 3.3.3 Broken GFCI Test Button

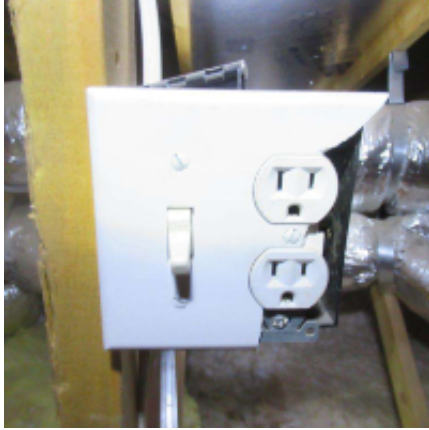
Description	• Switch/Outlet Combo Junction	Location	• Attic
Condition	• Damaged	Risk	• Electrocutation Hazard

Image 3.4.1 Broken Outlet Cover

Repair or Replace

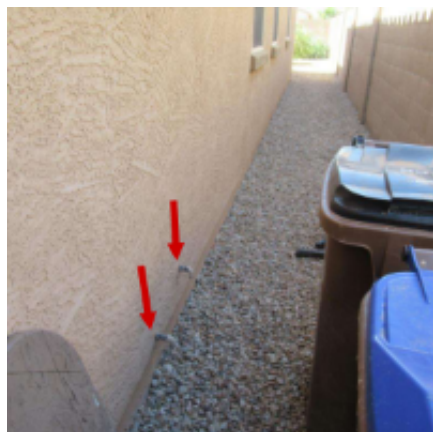
Repair or Replace - Immediately: Water heater discharge pipe is too short/far from ground. Steam dissipation can cause scalding to those standing nearby. Typically this should terminate 6 inches from the ground, but may vary by jurisdiction.

Image 5.1.1 Discharge Pipes on West Wall

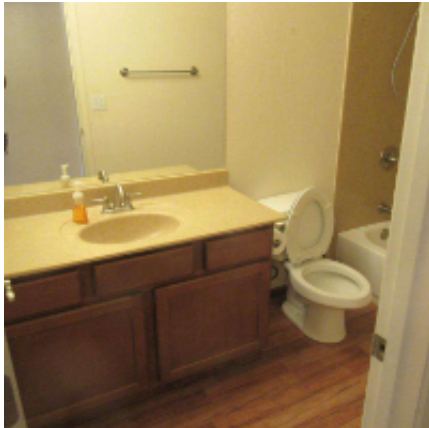
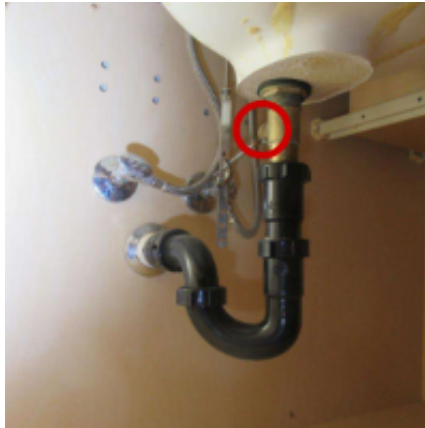
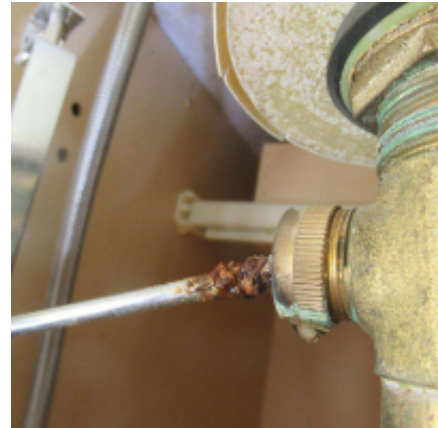
Image 5.2.1

Repair or Replace - Immediately: A leak is present at the stopper rod/drain connection. The mechanism can be dismantled to check seals for wear or cracks.

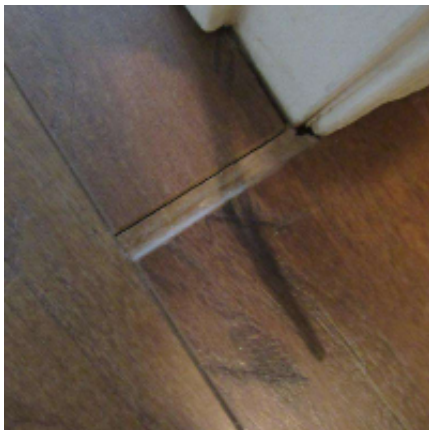
Description	• Hardwood • Ceramic Tile	Location	• Master Bedroom • Kitchen
Condition	• Gap • Minor Delamination	Risk	• Continued Delamination • Cosmetic

Image 6.1.1 Hardwood Flooring Gap - Master Bdrm Entry

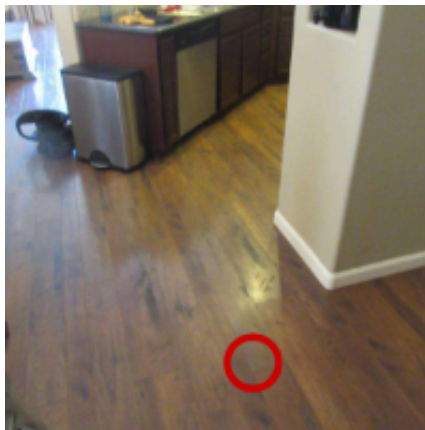
Monitor for Changes The corner of a hardwood flooring piece in the kitchen is delaminating and may get worse over time. Please monitor it at your discretion.

Image 6.1.2 Delamination spot in kitchen

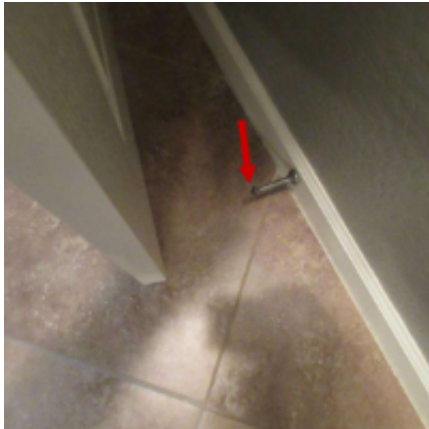
Repair or Replace Two of the door stops are missing the rubber bumpers that absorb the impact without denting the door. These can be purchased at your local hardware store and installed easily.

Image 6.2.1 Laundry Room

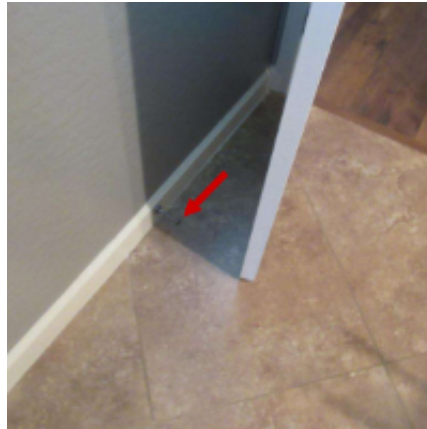
Image 6.2.2 Main Bathroom

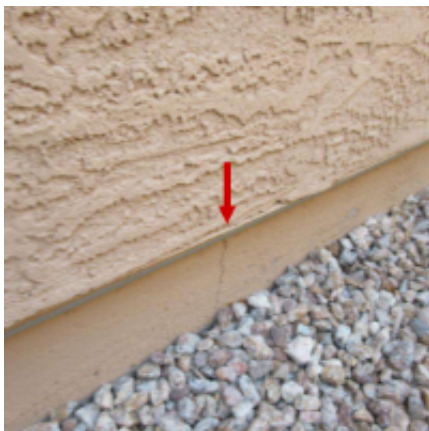
Image 7.1.1

Description	• Concrete	Location	• East Side of Home
Condition	• Hairline Cracked	Risk	• Normal Settlement

There are typical settling cracks in the foundation walls that would not need a specialist evaluation.
