Property Inspection Report

**10013 East Harmon Avenue
Las Vegas, NV 89119**

April 12th, 2019

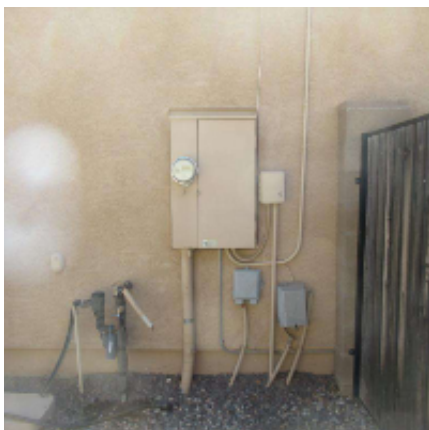
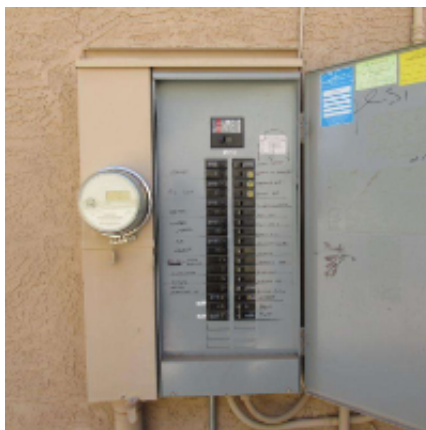
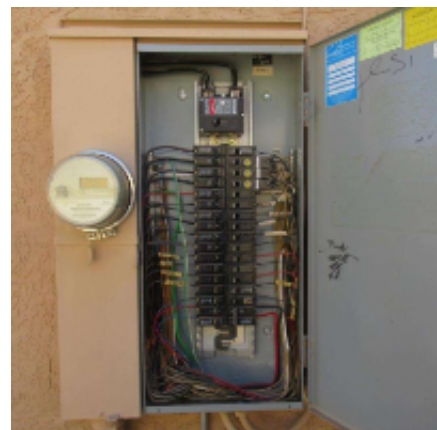
3.1 Main Disconnect / Service Box Electrical	Description	<ul style="list-style-type: none"> Breakers 	Location	<ul style="list-style-type: none"> Exterior West Side
--	--------------------	--	-----------------	---

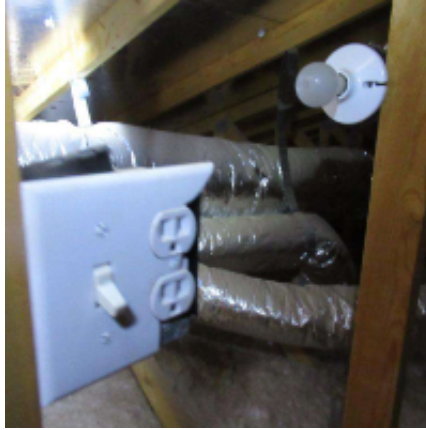
Image 3.4.2

Description	• Switch/Outlet Combo Junction	Location	• Attic
Condition	• Damaged	Risk	• Electrocutation Hazard

Repair or Replace

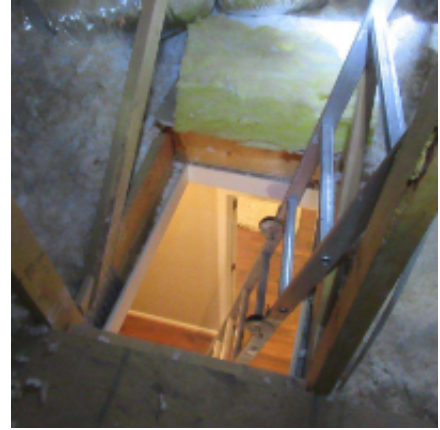
Image 3.4.3 Entry to Attic
